Hecla Mining Company

ESCALANTE UNIT

SUBJECT: Proposal for Closure of the Hecla Escalante Unit's
Tailings Facility

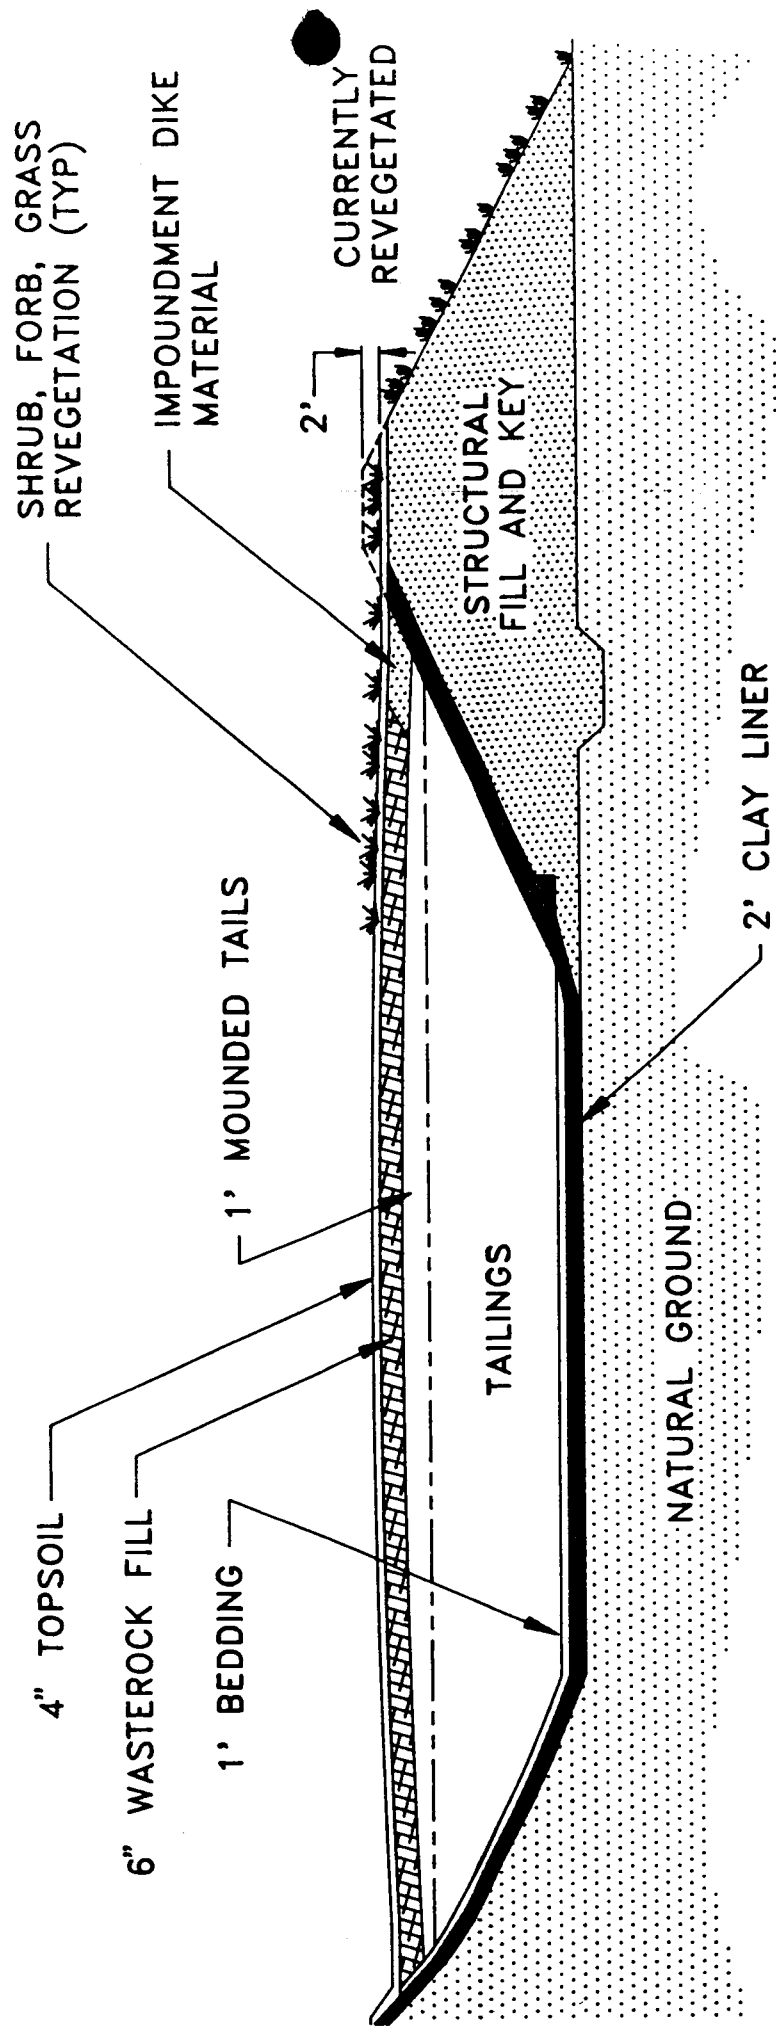
EAST/WEST SECTION ESCALANTE SILVER MINE TAILINGS CLOSURE PLAN

The attached diagram shows an East/West cross section through the tailings impoundment. This section shows the original ground surface, the clay liner, tailing material, wasterock, topsoil and vegetation layers.

As stated above, the tailings will remain in place. Hecla will recontour the tailings area with the use of wasterock and topsoil to assure the area is left in a stable condition. The recontouring will involve completely filling the tailings pond area such that no water will be impounded on the site and that surface flow and run-off will be directed around the site and into the natural channel without affecting the face of the original containment structure. Storm events or runoff occurring in the basin above the tailings containment area will be diverted via existing canals around both sides of the impoundment so that surface flow is not channeled across the reclaimed surface and the face of the impoundment structure. Any storm events or runoff originating on the containment will be diverted to the containment sides and then to the above mentioned canals. The present canals are currently conditioned to contain a one-hundred (100) year, six hour flood event. The canals will channel storm water to the natural water course below the tailings. Considering the size of this small arid basin (with no visible gullies or watercourses), we believe that the basin will be left in a stable condition that will avoid future damage to the hydrologic system.
